National Highway
Traffic Safety
Administration

Case Vehicle (A): 1998 Chevrolet
 Type: Venture LS, 4 x 2, 4-door APV
 Driver: 64-year-old female
 CDC: 12-LYAS-2, 12-FCEN-3

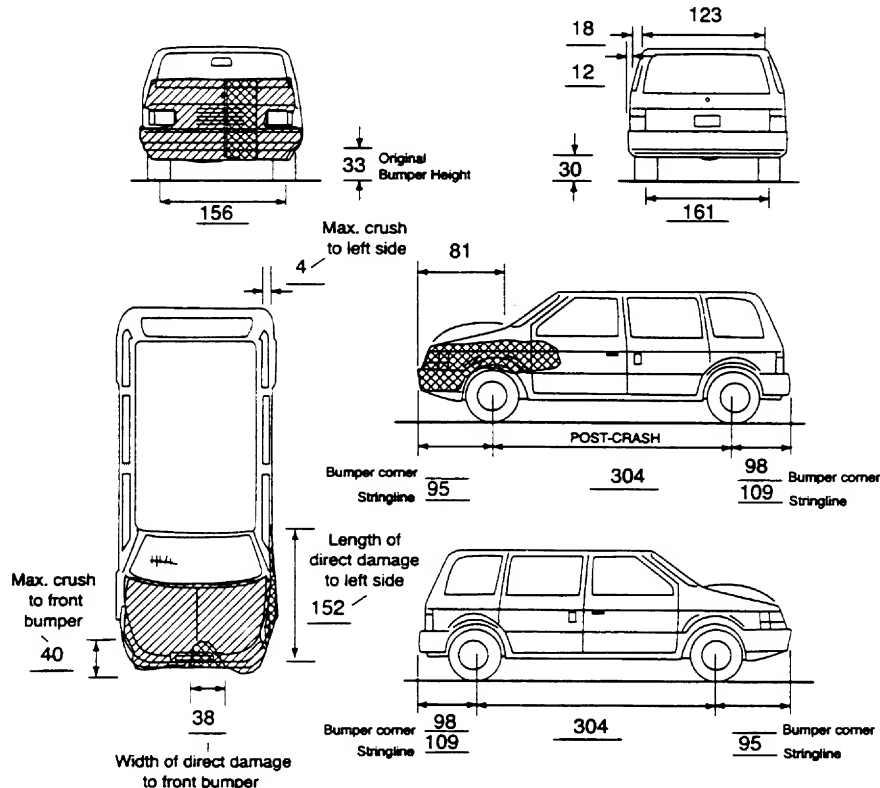
VEHICLE DAMAGE

Specific Impact No.	Location of Direct Damage	Location of Field L
1	43 cm Rt of LFBC	From bumper BC to BC
2	Begin LFBC - 152 cm to rear	500 cm

Specific Impact Number	Plane of Impact C-Measur.	Direct Damage		Field L	C ₁	C ₂	C ₃	C ₄	C ₅	C ₆	±D
		Length (DDL)	Max Crush								
1	1	38	41	132	3	15	41	20	9	4	-13
			-1		-13	-4	-1	-1	-4	-13	
1	1	038	040	132	000	011	040	019	005	000	-013
13	14	15 16 17	18 19 20	21 22 23	24 25 26	27 28 29	30 31 32	33 34 35	36 37 38	39 40 41	42 43 44 45
2	4	152	4	152							
2	4	152	4	152	999	999	999	999	999	999	+999

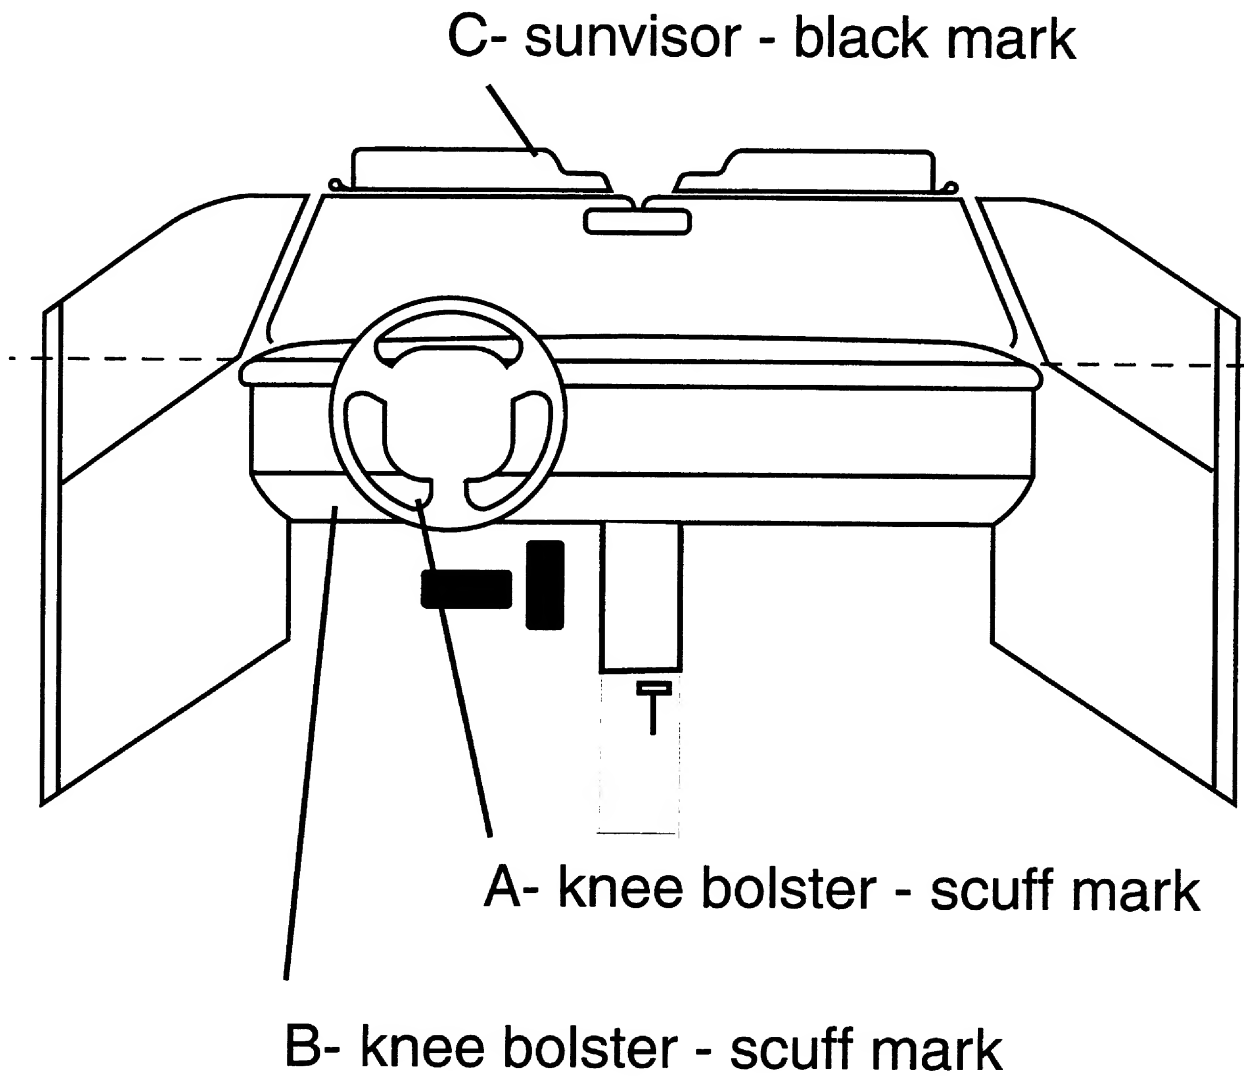
VEHICLE OCCUPANT CONTACT DIAGRAM

Contact	Interior Component Contacted	Occupant No. if Known	Body Region if Known	Supporting Physical Evidence	Confidence Level of Contact Point
A	Knee bolster	DR	Rt. knee	Scuffmark	1
B	Knee bolster	DR	Lt. leg	Scuffmark	1
C	Sunvisor	DR	Head	Black mark	3
D					
E					
F					
G					
H					
I					
J
